City of Baltimore Wet Smoke and Dyed	Page 1 of 2	
Sewershed: Gwynns Falls	Company: Savin	Date: 4/22/2009
Test to be performed:  Smoke Dyed Water X	Ground Condition:  Dry ☑ Damp ☐ Wet ☐	Supervisor: JAW
Manhole_ID: S09I018MH	Test ID: <u>D1032-008003</u>	Notification Made: NA (Residents, Fire, 311)

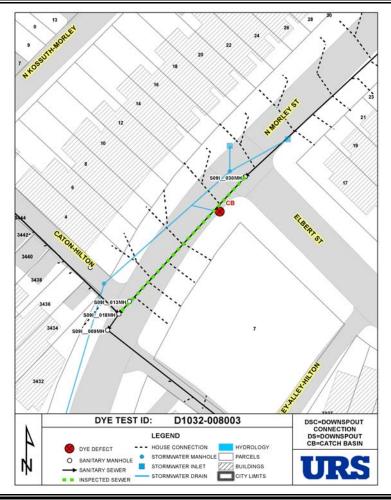
Field Sketch: Show all manholes with Numbers, Blower Placement Locations, Sandbag or Isolation Locations, Street Names, Building Addresses and Locations, Defect Locations and Photo Numbers.

Defect Loc	Obs_ClockFrom	Obs_ClockTo	Observation	Obs_Remarks
0			Start of Survey	
0			Manhole	S09I030MH
23.20000076			Dye Test Visible	@ IR, 1/2 GPM
23.20000076	10		Infil Runner	@ jt
27.79999924			Dye Test Visible	@ IR, 1/8 GPM
27.79999924	08		Infil Runner	@ jt
30.60000038			Dye Test Visible	@ IR, 1/4 GPM
30.60000038	04		Infil Runner	@ jt
30.60000038			Dye Test Visible	@ IR, 1/4 GPM
30.60000038	09		Infil Runner	@ jt
38.09999847			Abandoned Survey	NO MORE DYE VISIBLE
